## Towing Procedures and Ring Feeder Care

### Caution When Towing Trailers Fitted with Ring Feeder Tow Hitches

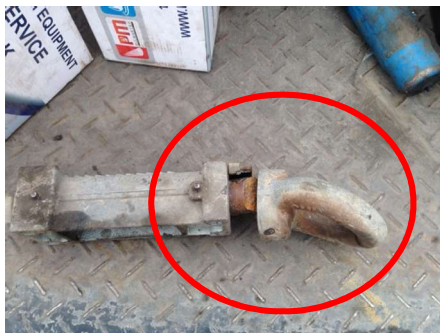
**Picture 1** – Clearly shows a ring feeder that has failed due to excessive speed in rough conditions.

All Pit Master LED Lighting Towers are fitted with ADR compliant ring feeder components and **Caution needs to be observed at all times** when towing, reversing, hitching and unhitching Pit Master LED Lighting Towers. Towing procedures should be followed as listed in the Pit Master Operations and Maintenance Manuals or Towing Procedures also referenced in Technical Bulletins # 6 and # 7.

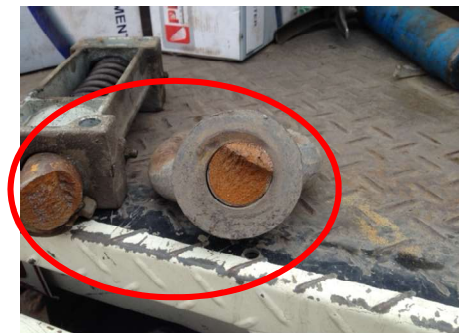
**Picture 2** – The above picture shows where the ring feeder shaft has been bent through jack-knifing the trailer, causing the shaft to fail.

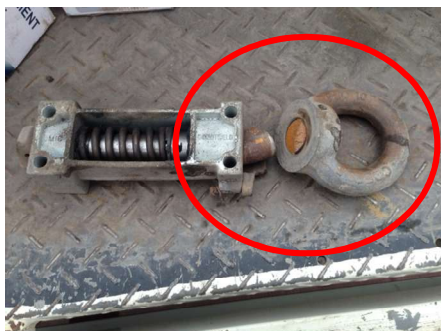
**Picture 3** – The above picture again shows where the ring feeder shaft has been bent through jack-knifing the trailer, causing the shaft to fail.

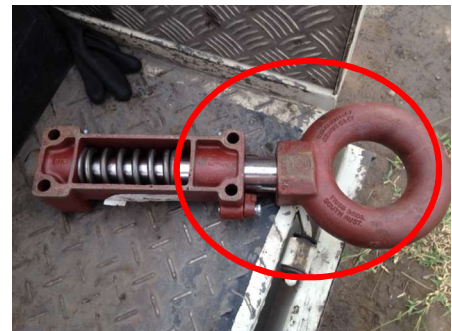
**Picture 4** – The above picture shows where a new ring feeder shaft has been slightly bent due to towing abuse.
